Boffa Miskell

Kennedy Point Marina

Kororā Construction Monitoring & Management Plan
Prepared for Kennedy Point Boatharbour Ltd

31 August 2021

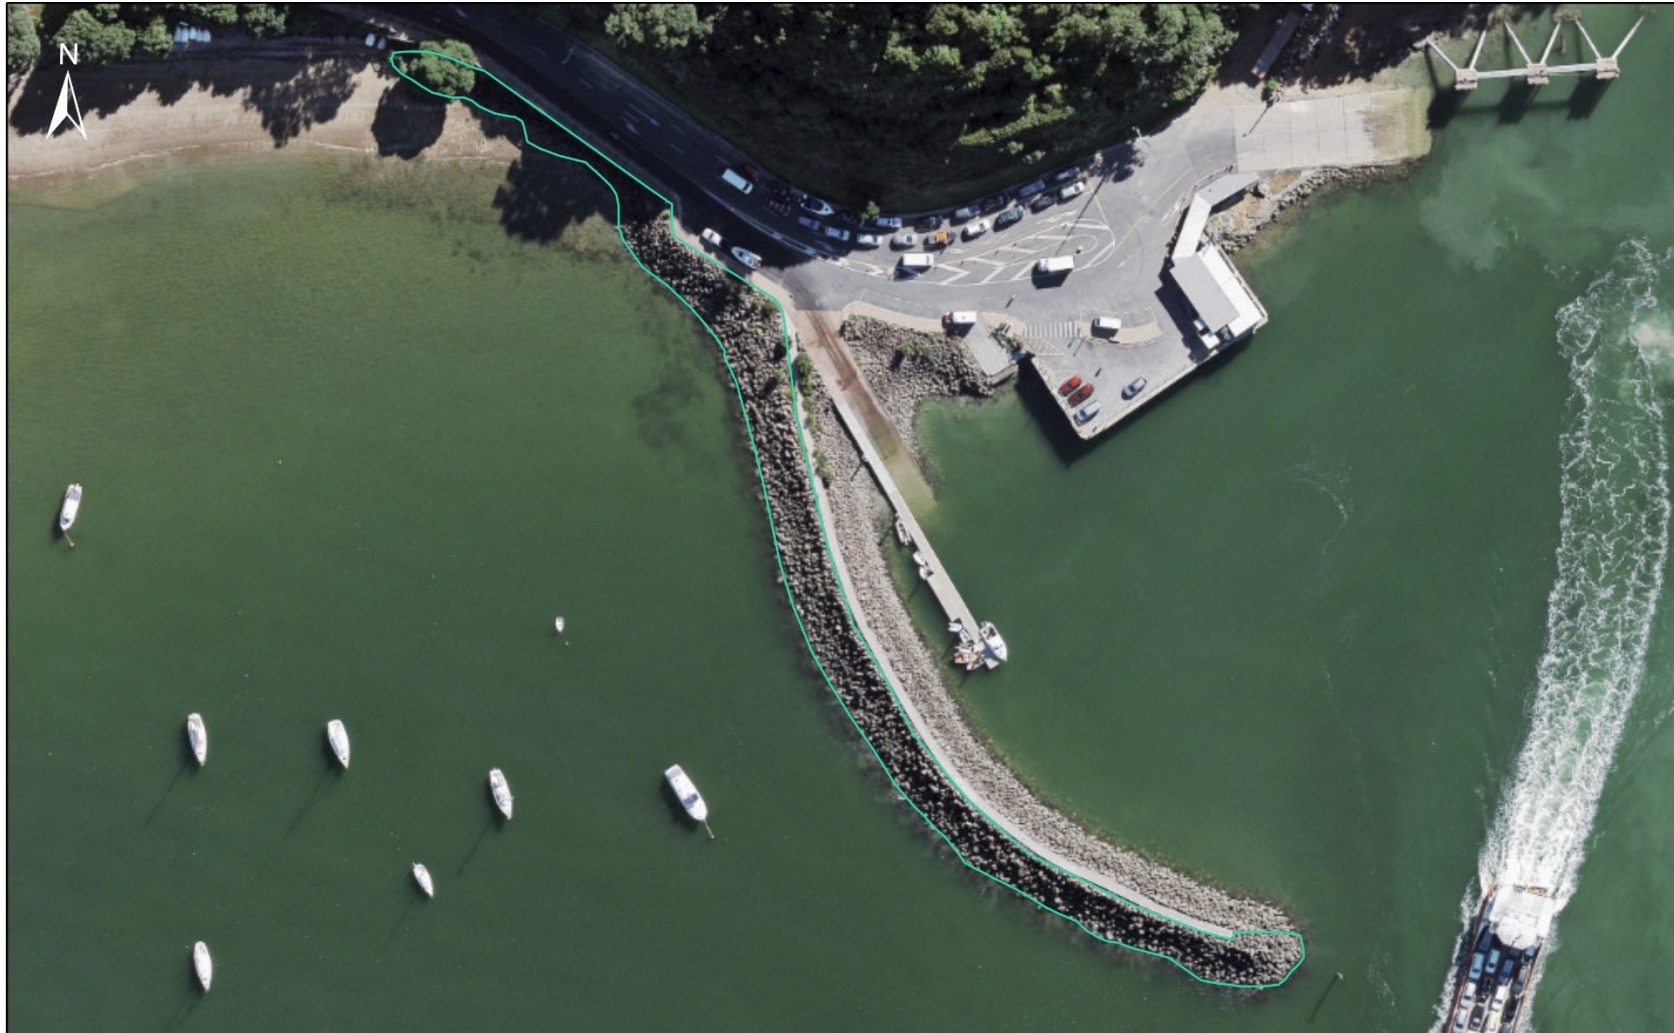
Map 1: Penguin Construction Monitoring Area (PCMA) for purposes of condition 24A

Map 1: Penguin Construction Monitoring Area (PCMA) for purposes of Resource Consent condition 24A.

In July 2021, the Environment Court clarified that the monitoring programme required by condition 24A applied to the marina side of the breakwater and an area of the foreshore up to the first Pohutukawa tree (refer to Map 1).

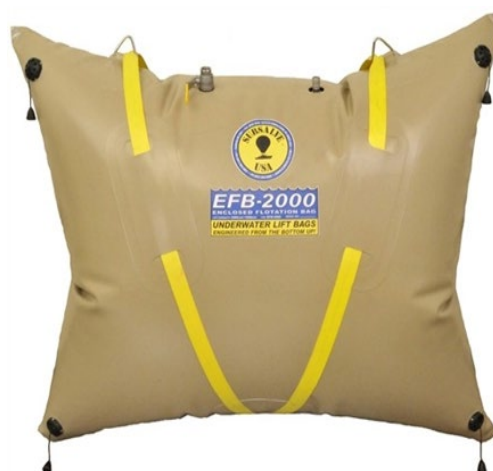
Photo 5: Example of underwater lift bag

Due to the small number and size of the rocks in the vicinity of pile 11 (refer to Map 4 and Photo 4), these rocks will be shifted manually, or potentially using an underwater lift bag (Photo 5).

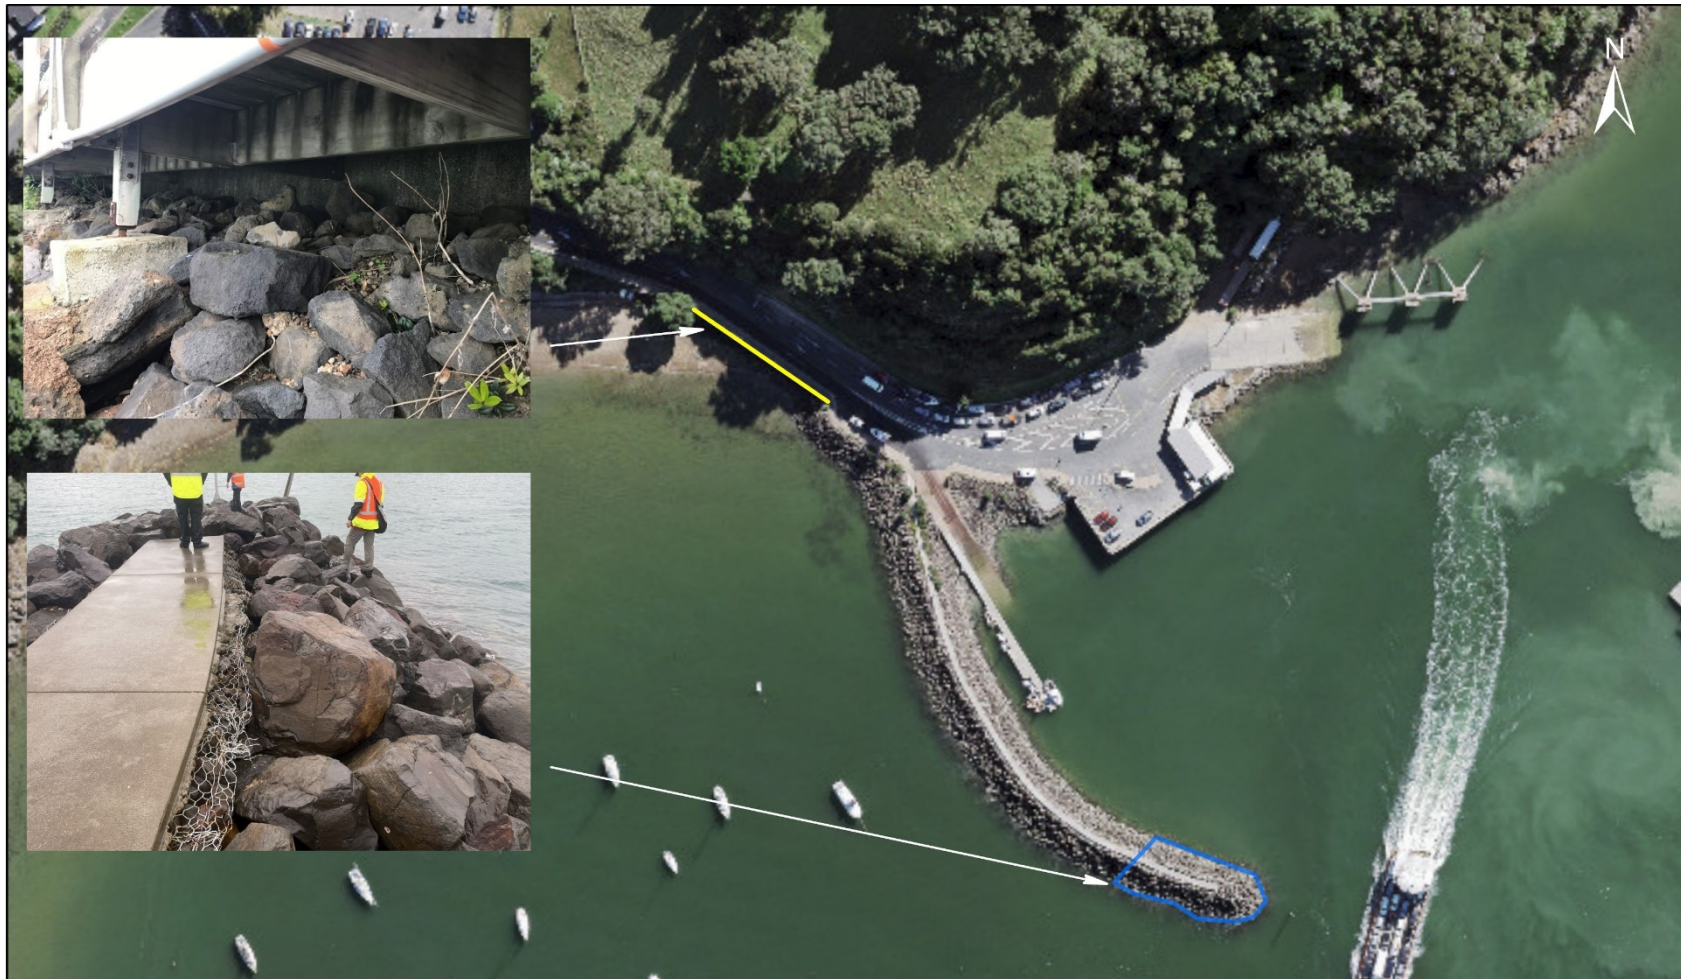
Map 6: Proposed sites for penguin translocation and nest box installation

- Proposed Location for Nesting Boxes
- Proposed Kororā Release Site

Data collected from all previous kororā surveys on the breakwater will be used in the first instance to identify areas within the release site (identified in Map 6) where birds have not been recorded. At those locations, the rock will be inspected by the penguin expert to determine an appropriate crevice in which to release the bird. The crevice must be above MHWS and provide a pathway for the bird to the water. Prior to releasing the bird, the crevice will be checked to ensure that it is not already occupied by other birds. If it is found to be vacant, the bird will be released into the crevice and the GPS co-ordinates of release site taken. A different crevice will be used each time, to ensure that multiple birds are not placed into the same release site on different occasions. Only in instances where two birds are being translocated from the same burrow will two birds be placed in a translocation crevice together.

In addition, wooden nest boxes will be installed several meters apart under the board walk (refer to Photo 7 and Map 6). The nest boxes will be designed as per the DOC guidelines²¹ (provided in Appendix 2) and will be constructed using treated timber. After their construction, the nest boxes will be left exposed to the elements for a minimum period of 3 months with the lids off on a diagonal to allow rain to flow over them. The boxes will be installed on soil (not concrete) to enable the birds to scrape and make their nest on this substrate (see Photo 8). It is estimated that approximately five nest boxes will be installed at the proposed location (refer to Map 6), however the final number will be determined on site to ensure suitable separation and access is achieved. It is likely that shifting of some small rocks will be required to maximise nesting opportunities. This nest box establishment work will be undertaken in the presence, and under the guidance, of a SQEP.

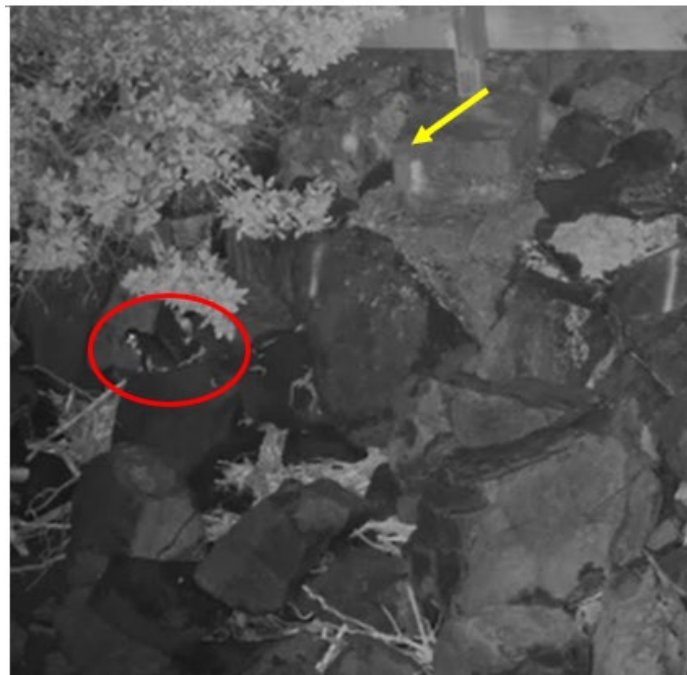
Photo 6: : Video surveillance footage capturing two penguins (red ellipse) traversing the construction footprint on the breakwater immediately below burrow 27 (yellow arrow), recorded on 3/5/21 at 18:37 hrs).

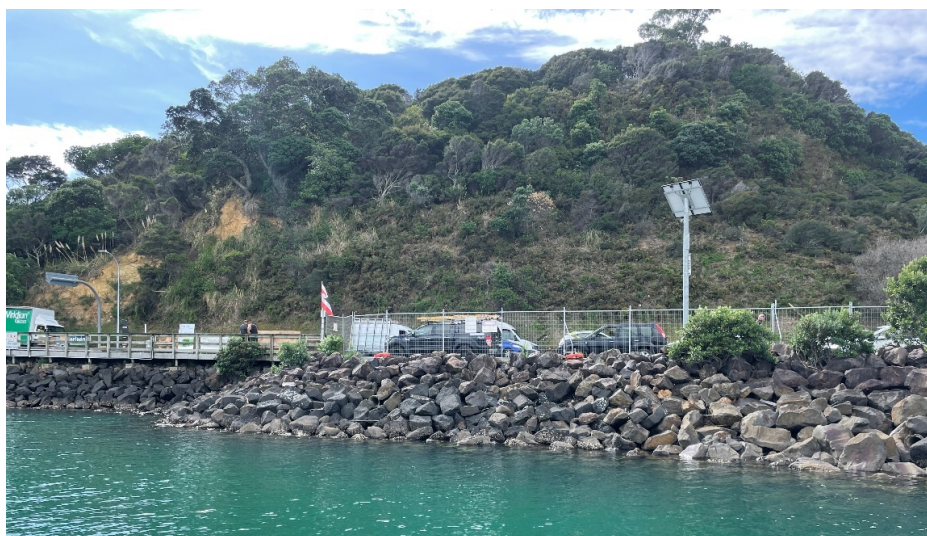
Photo 7: Kennedy Point breakwater showing boardwalk on the left of the photo.

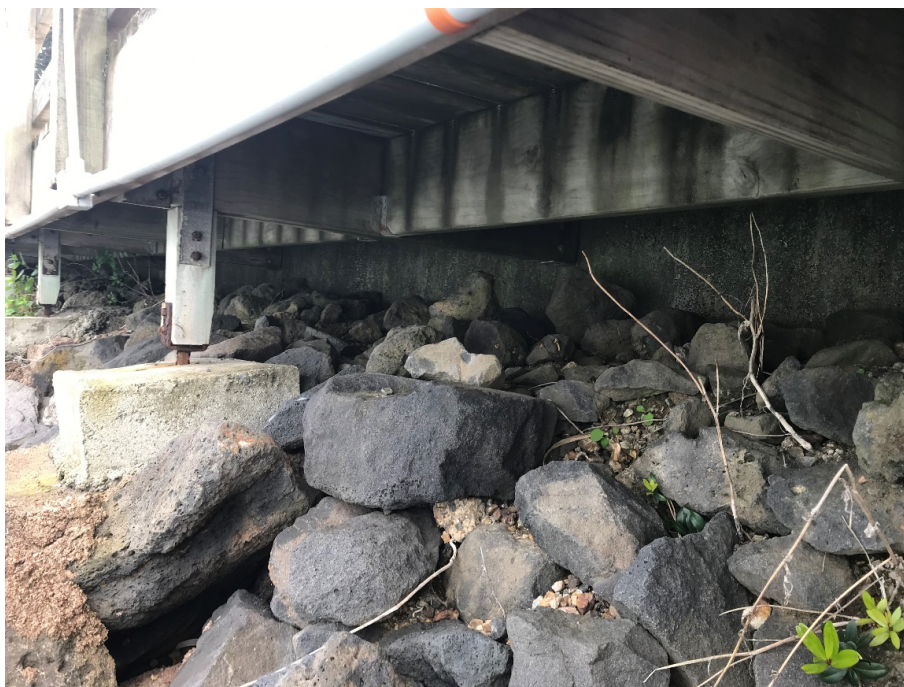
Photo 8: Area under boardwalk where nest boxes are proposed to be installed. Note soil substrate can be seen under the smaller rocks.
